NEVADA SITE OFFICE

Coal Tar Flaking in Fire Protection Water Supply

Coal Tar Flaking and Corrosion in the Device Assembly Facility Fire Suppression System

2009 DOE/Contractor Fire
Safety Workshop

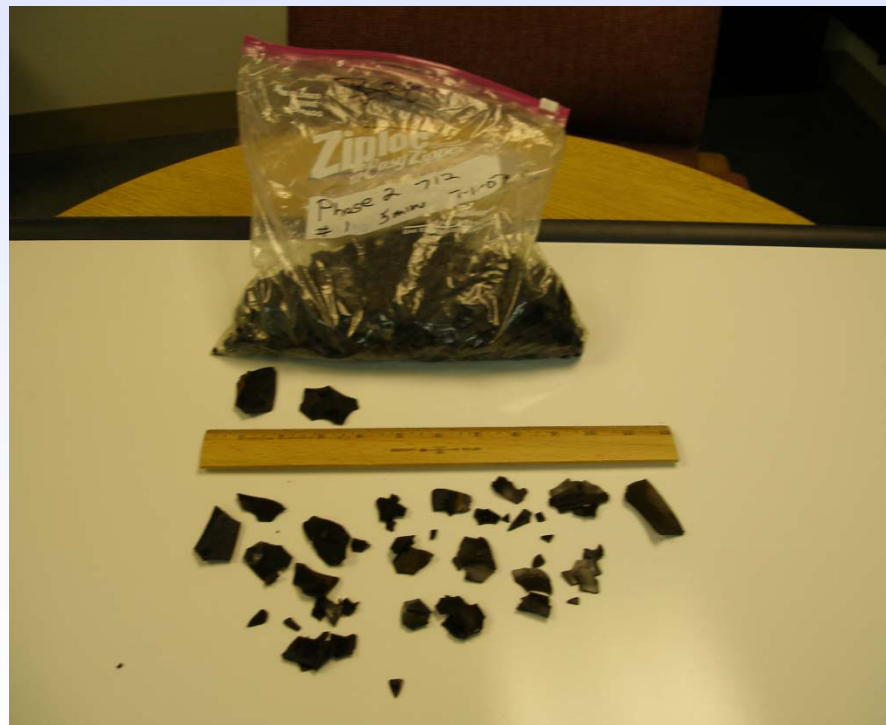
In FY-07 significant increase in coal tar collected during flush
(one strainer/one flush)

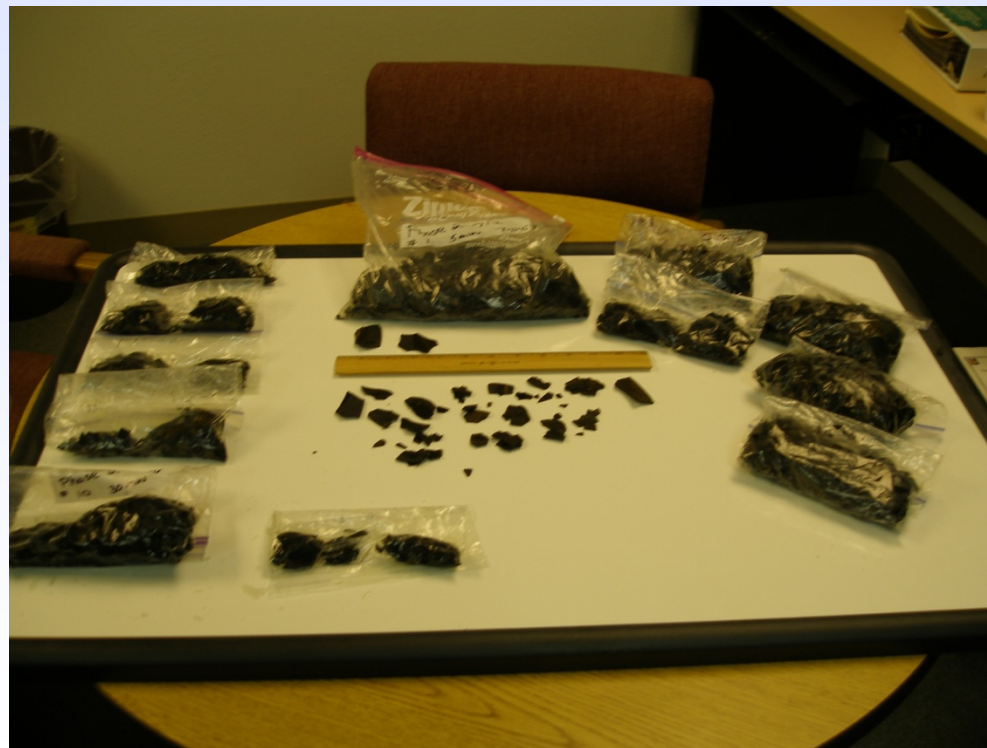
In FY-07 significant increase in coal tar collected during flush
Cont'd

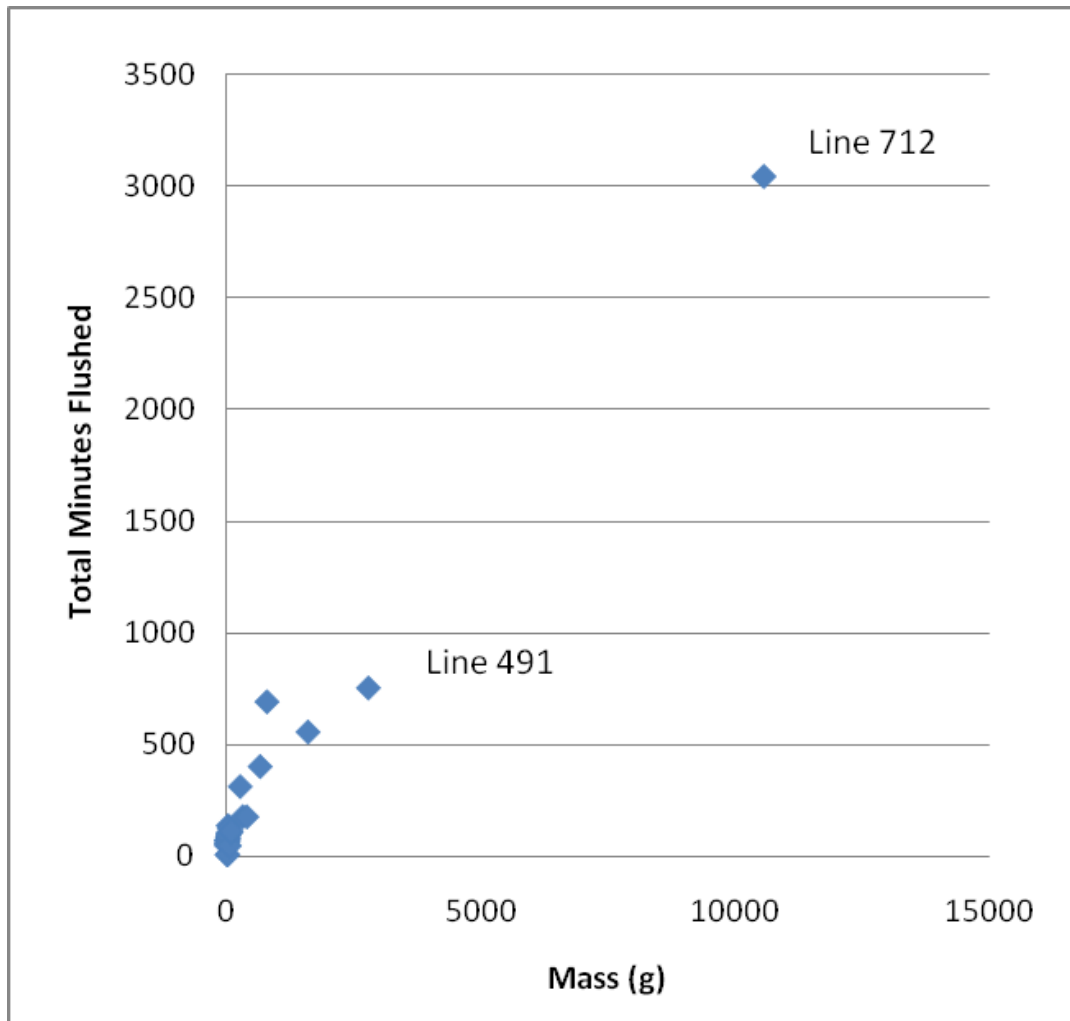
CTE Mass Loss vs. Flush Time

- Mass loss by line varies over four orders of magnitude.
- Generally linear relationship between flush time and mass loss.

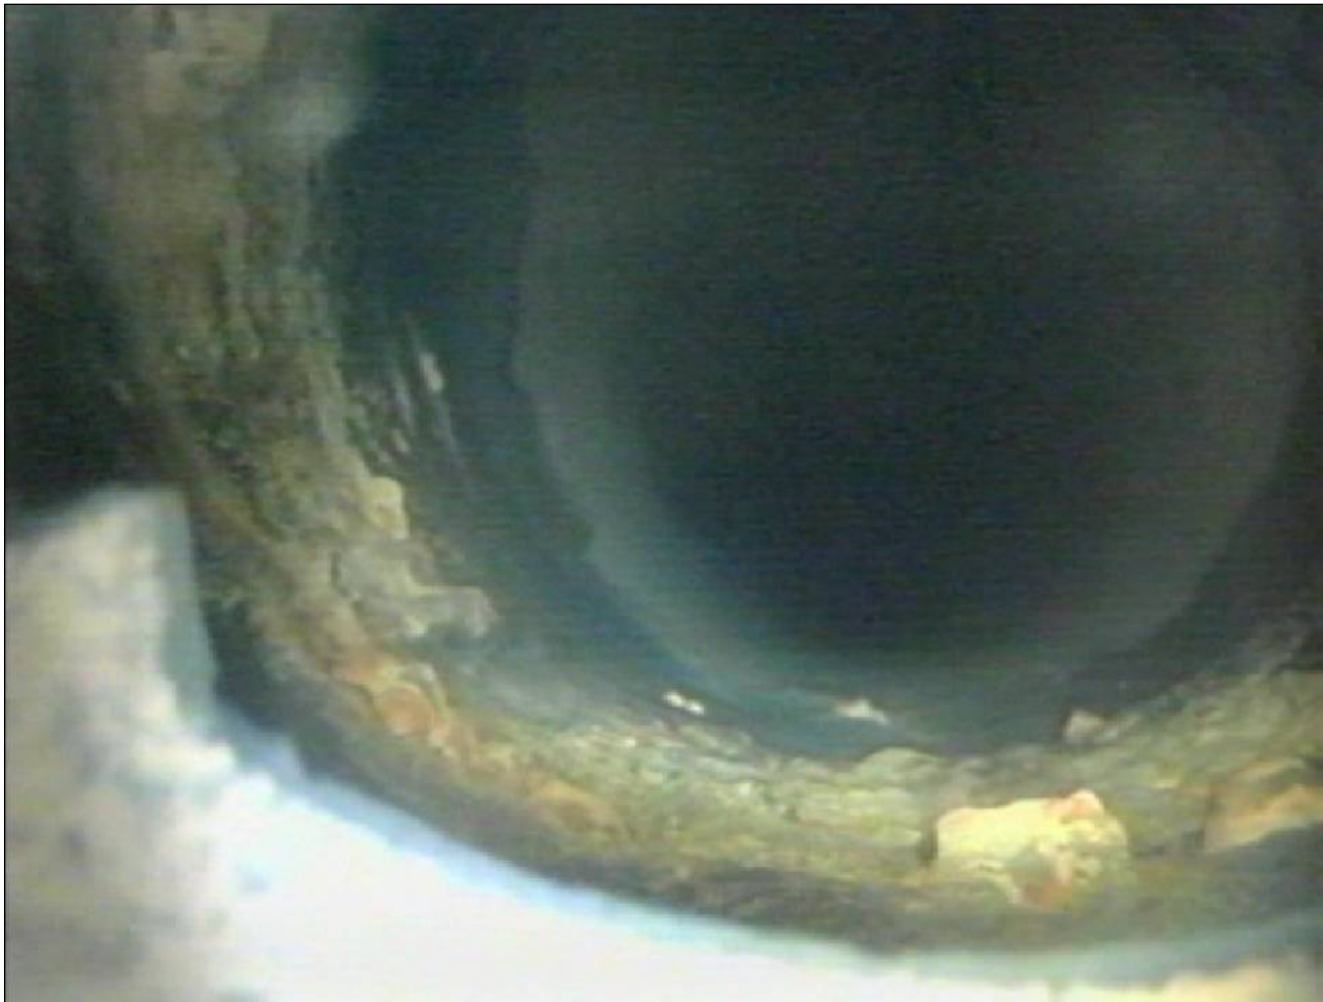
Liner Damage at Welds: Line 370-1W, Third Joint (87 ft.)

- Pipes welded, not flange-fitted.
- Welding damage provides initiation points for delamination.
- Pits/blisters provide new initiation points.
- Lining continues to delaminate once initiated.
 - Poor adhesion + turbulence + viscous forces + corrosion.
- Supported by video: CTE lining loss well away from joints.
- Supported by flow rate data: flushes (<15 ft/sec).
 - Good CTE should withstand ~45 ft/sec.
- Current flushing protocol likely exacerbates delamination.
 - Oxygen for corrosion and high flow rates to strip CTE.

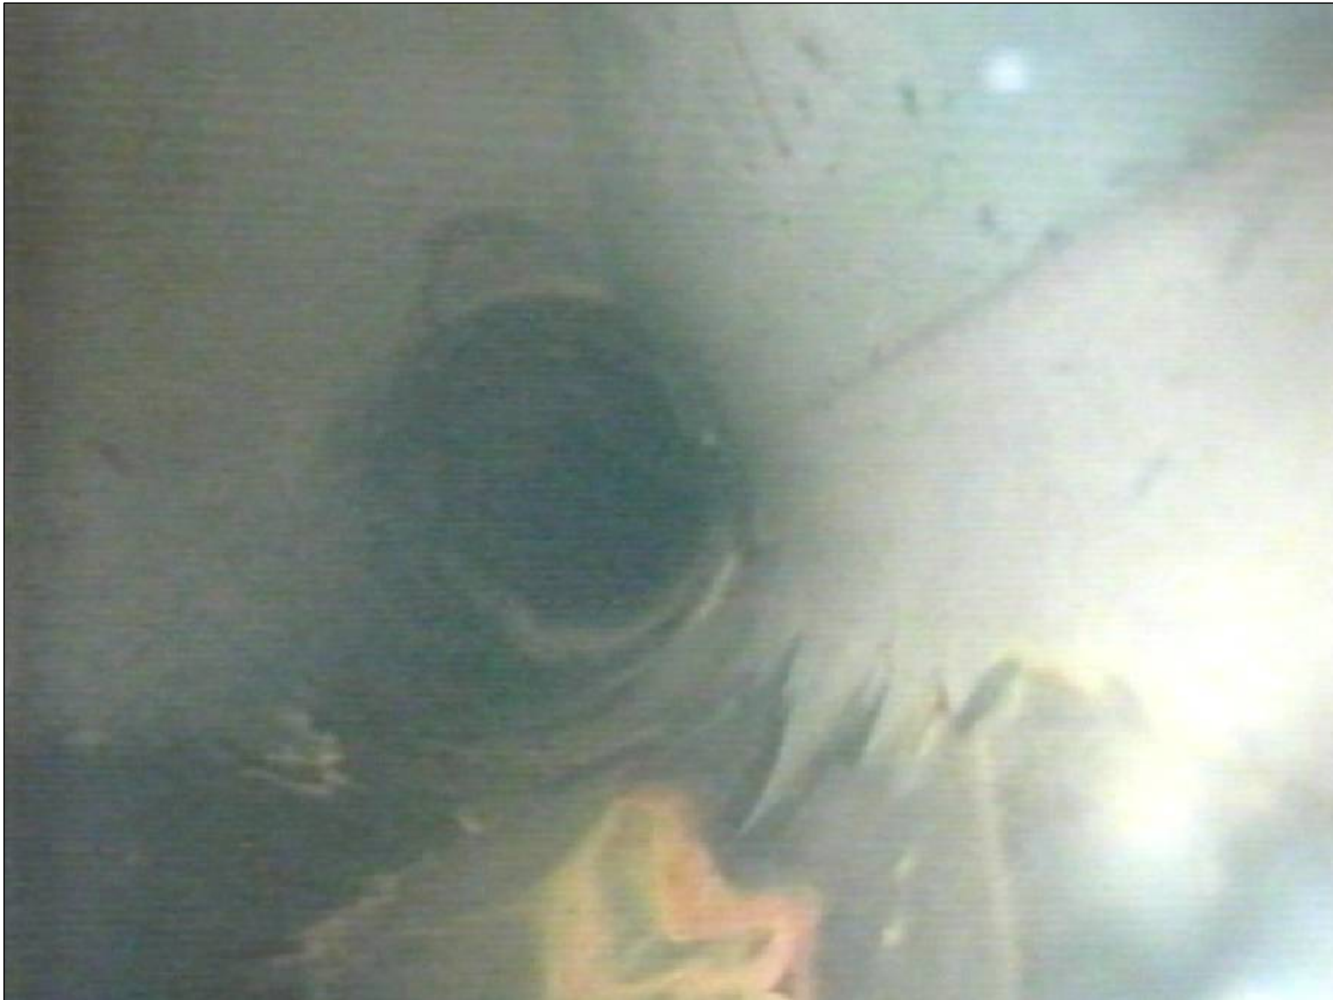
Line 491 (Between Joints 5 & 6)

Delamination:

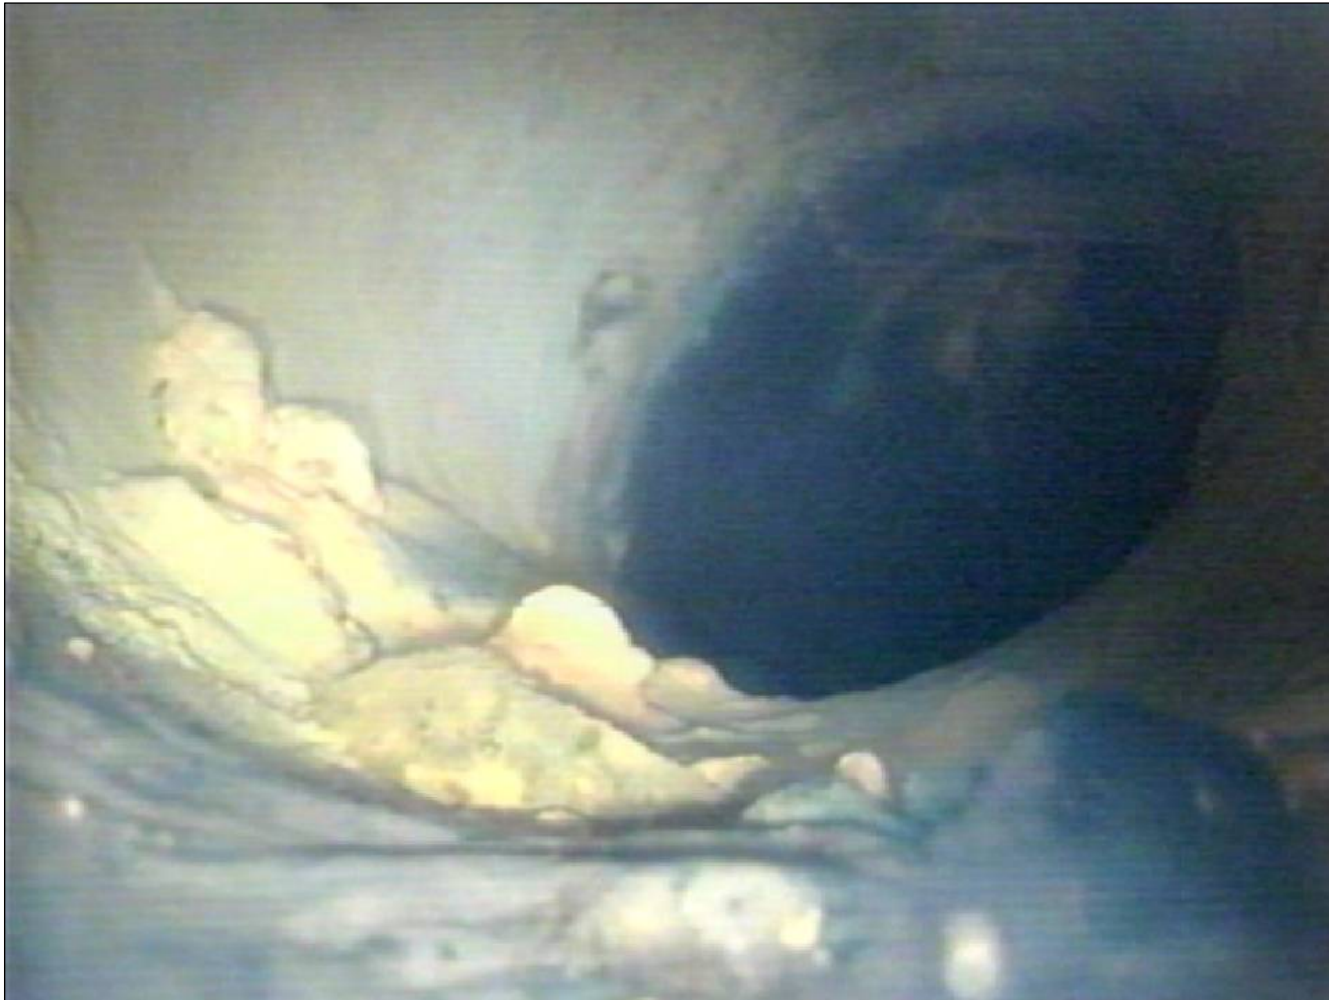
Line 370-1E, Second Joint (77 ft.)

- Water tested in each line opened for chlorine and MIC-producing bacteria common to fire suppression systems.
 - Aerobic bacteria
 - Acid-producing bacteria
 - Sulfate-reducing bacteria
 - Iron-related bacteria
 - Low nutrient bacteria
- All lead-in line water samples tested positive for some.
- Tubercles consistent with MIC observed with borescope.
- Residual chlorine levels essentially zero in most lines.

MIC Tubercles:

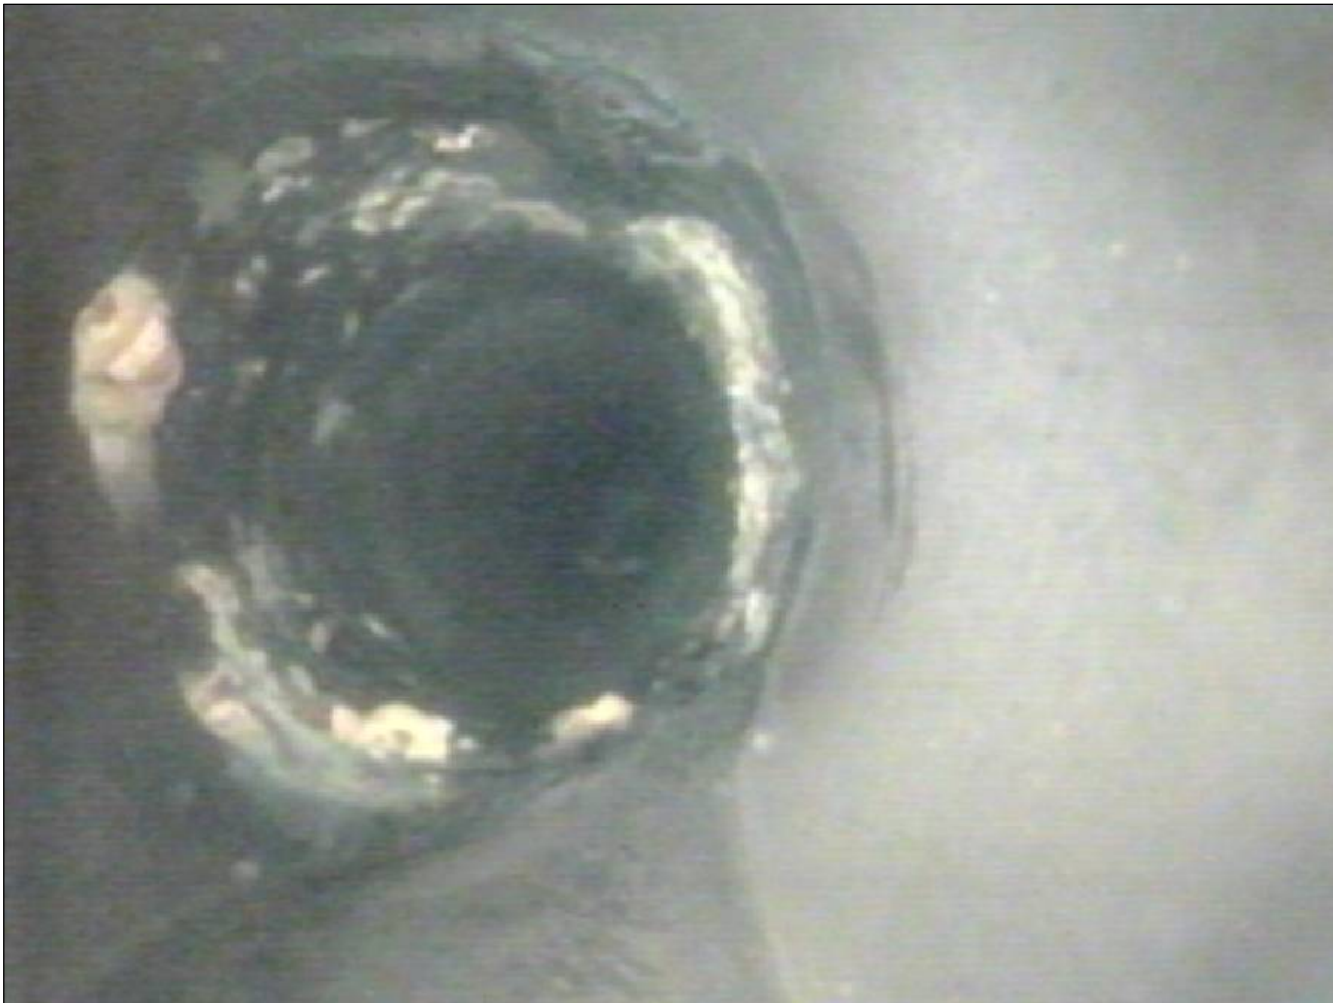
Line 711, Seventh Joint (131 ft.)

MIC Tubercles:

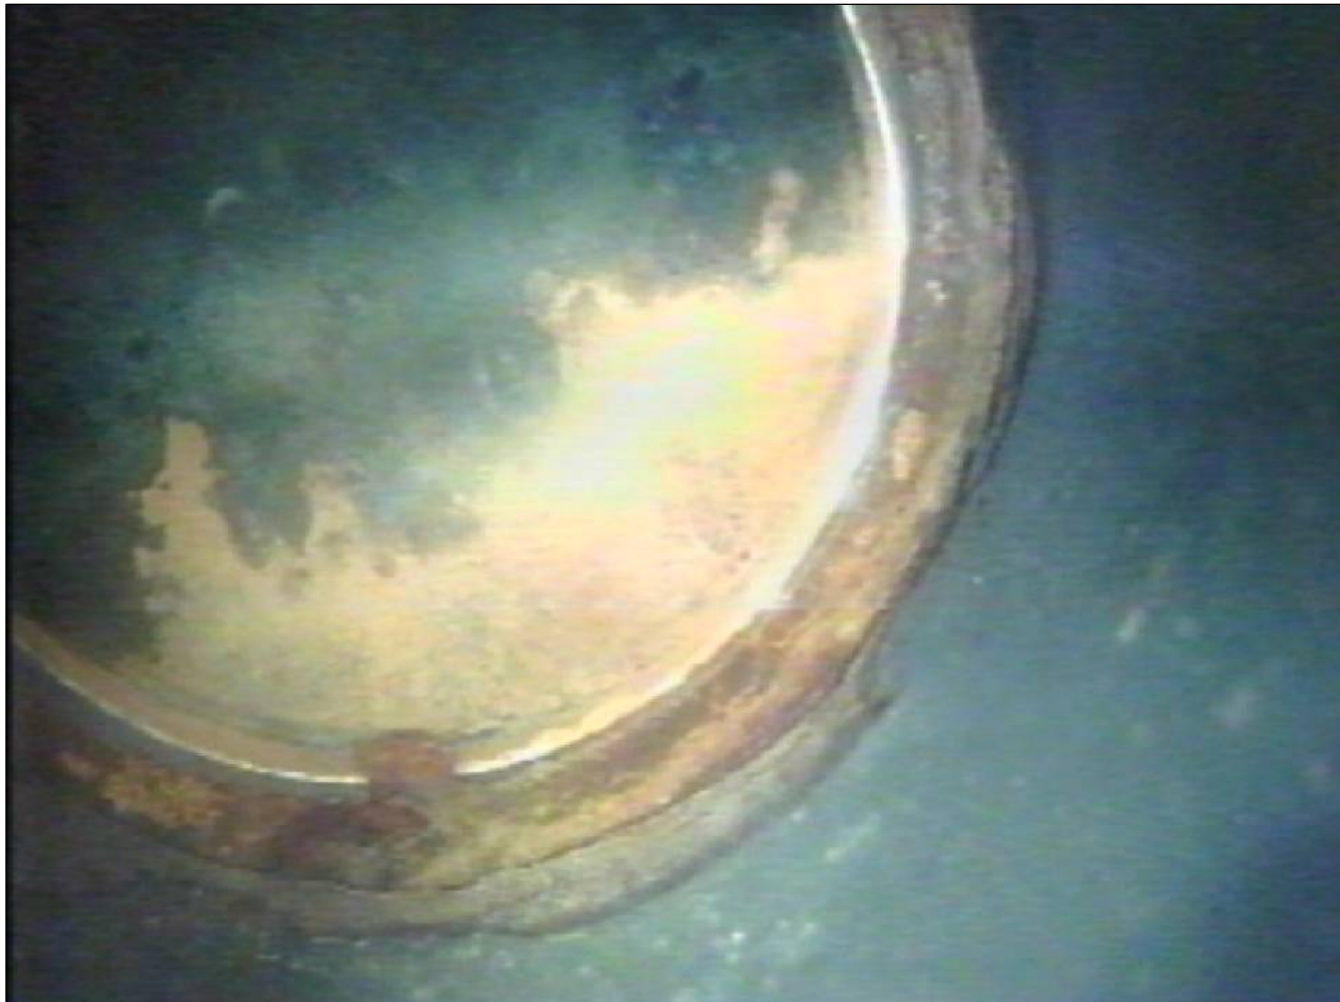
Galvanic Corrosion: Line 494 PIV/Pipe Intersection

- Brass Pressure Isolation Valves (PIVs) not electrically isolated from the carbon steel lead-in lines.
- Substantial corrosion noted at the brass/steel intersection.
- Damage confined to steel exposed under the edge of the lining adjacent to the PIV.
- Corrosion in this small area is accelerated by galvanic couple.
- Typically prevented with flange insulation kits.
- No insulating kits were specified or observed.

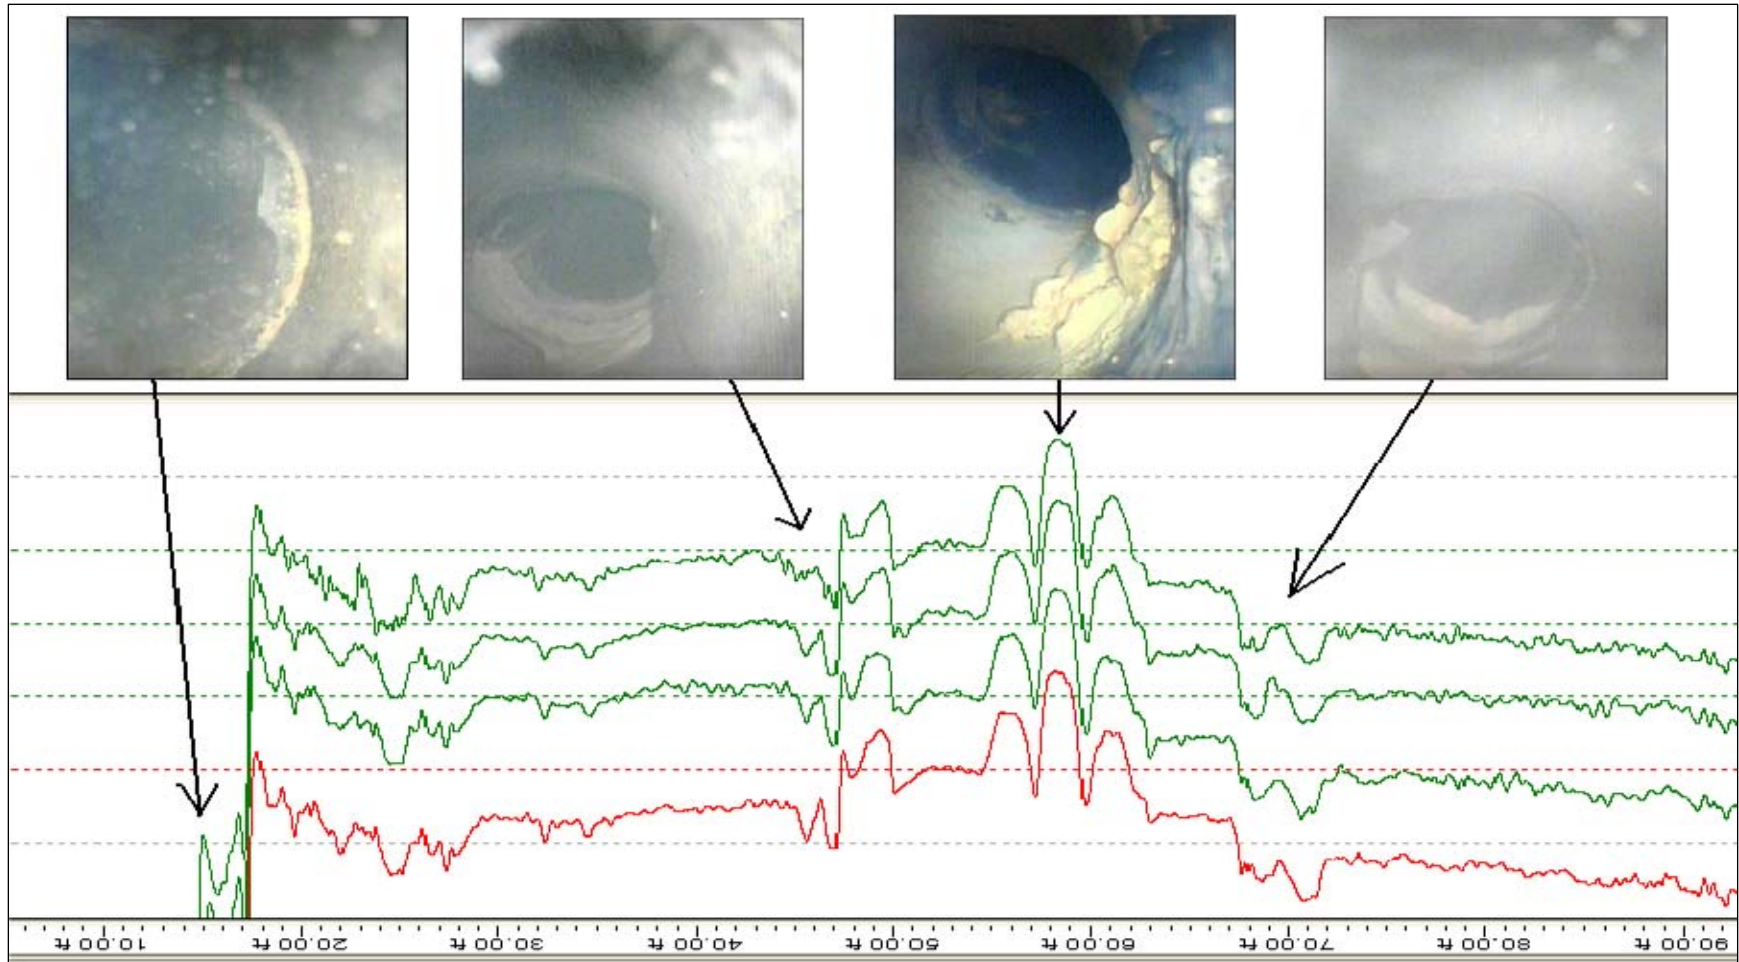
Example RFT Data: Line 370-1E

370-1E Feature	Max. Wall T Loss (% Nom)
Ductile Iron-to-Steel Flanged Joint	Not Recorded
First Welded Steel Joint	30%
Second Welded Steel Joint	20%
Third Welded Steel Joint	20%
Fourth Welded Steel Joint, End Inspection	Not Recorded

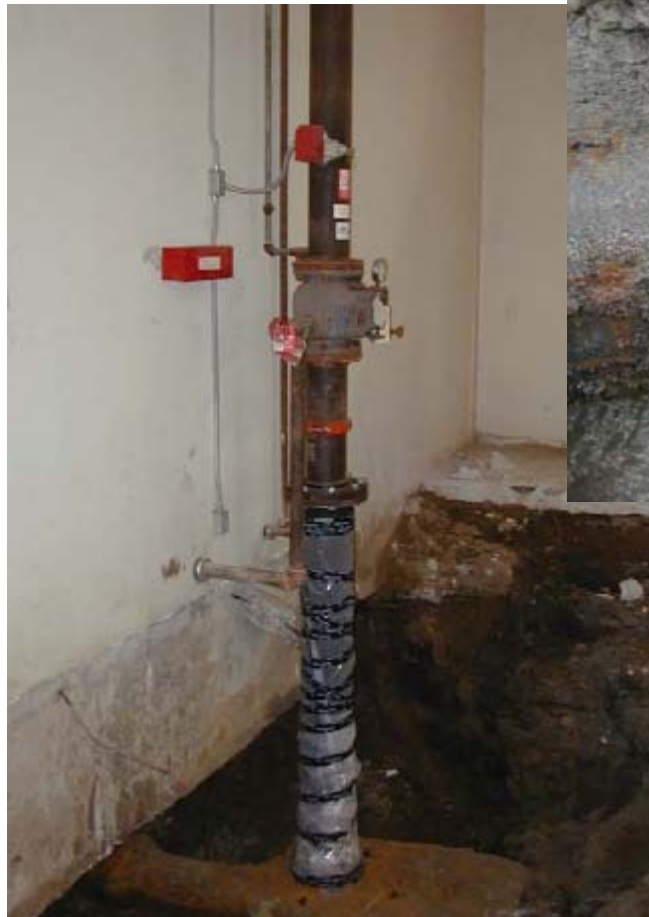
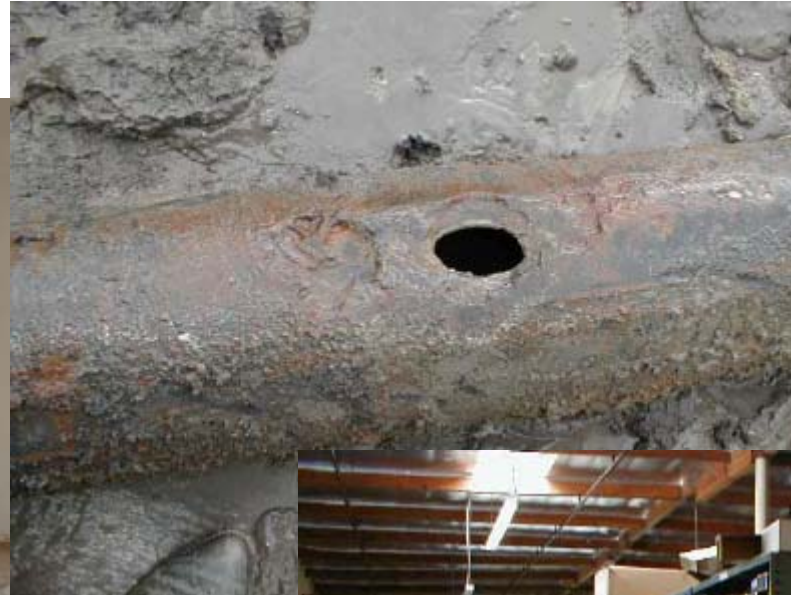
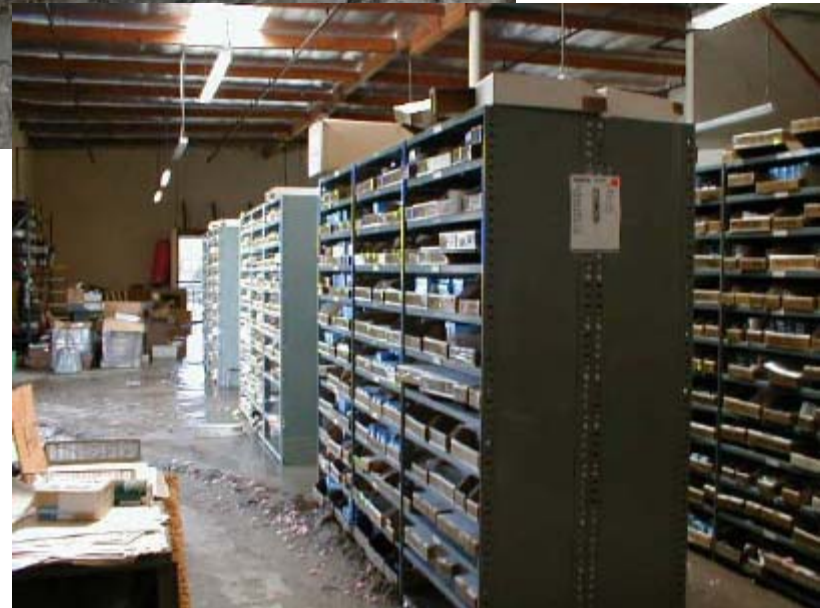
Ignored Electrical Continuity

- All lead-in lines electrically continuous with DAF:
 - Building ground system
 - Concrete-encased rebar and other concrete-encased steel.
- Not an uncommon problem with fire suppression piping.
- Creates galvanic corrosion cell between the lead-in lines and the copper and/or concrete-encased steel.
- Galvanic cell accelerates corrosion at breaks in coating
 - Both on interior and exterior surfaces.
- Typically prevented with flange insulation kits
- No insulating kits were specified or observed.
