Non-destructive inspection techniques to determine structural distress indicators in water mains

Rajani, B.; Kleiner, Y.

NRCC-47068

**A version of this document is published in / Une version de ce document se trouve dans :
Evaluation and Control of Water Loss in Urban Water Networks,
Valencia, Spain, June 21-25, 2004, pp. 1-20**

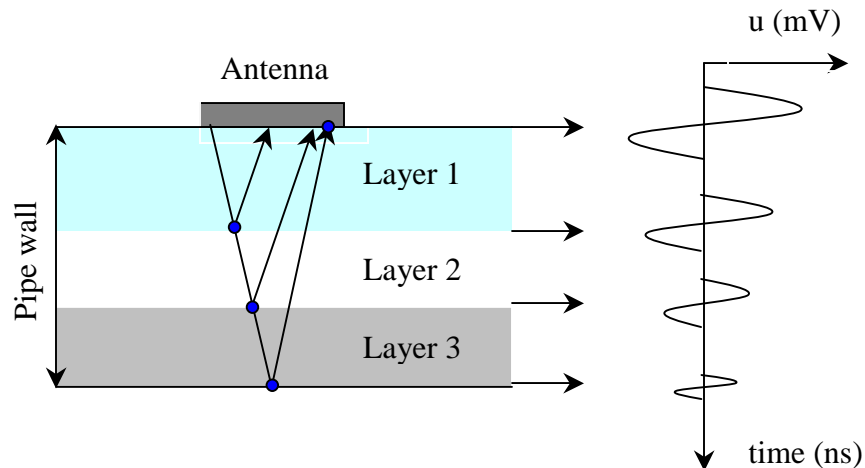
Fig. 10 Georadar arrangement in asbestos cement pipe.

Principle: Georadar technique is based on measurement of transit time and signal strength attenuation of electromagnetic impulses as they travel through a pipe wall thickness (Fig. 10). The technique is most applicable to asbestos cement pipes where the deterioration is often in the form of soft layers either on the outside or inside of the pipe or both. The thickness of each layer is determined from travel times and signal strength as well as the electrical properties of various layers. The technique was developed in the Netherlands and Australia where it has been used extensively for sewerage pipes and has recently (Slaats *et al.*, 2004, De Silva *et al.*, 2002) undergone tests for its applicability to asbestos cement water mains.
