NEVADA SITE OFFICE

Coal Tar Flaking in Fire Protection Water Supply

Coal Tar Flaking and Corrosion in the Device Assembly Facility Fire Suppression System

2009 DOE/Contractor Fire
Safety Workshop

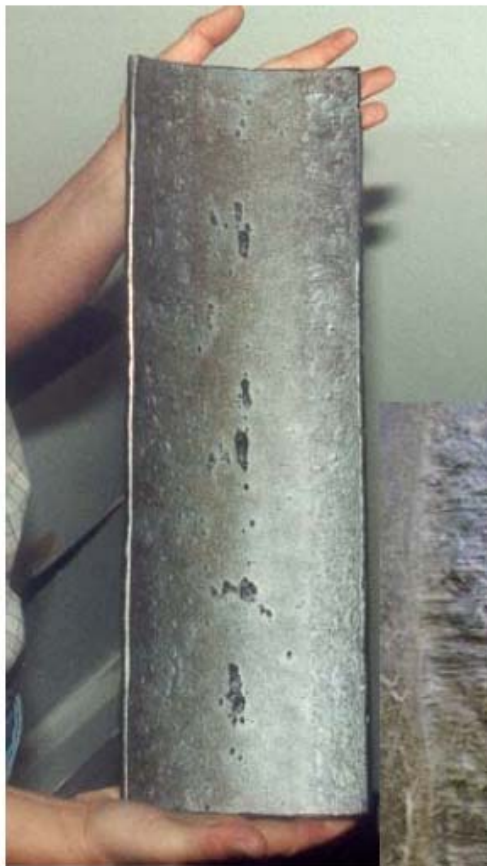
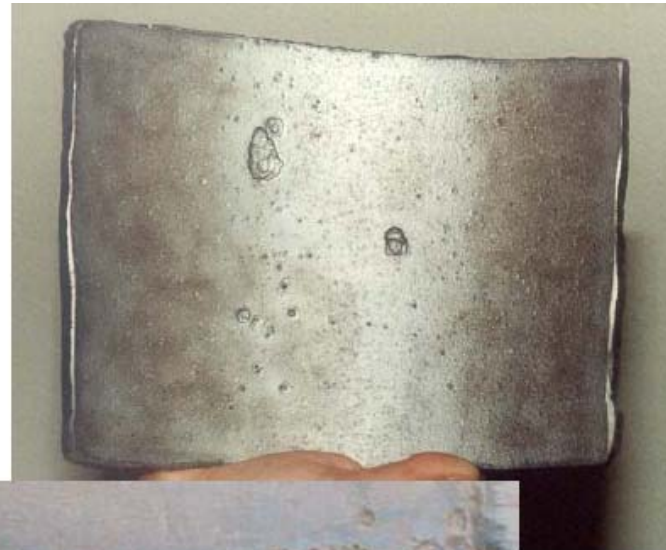
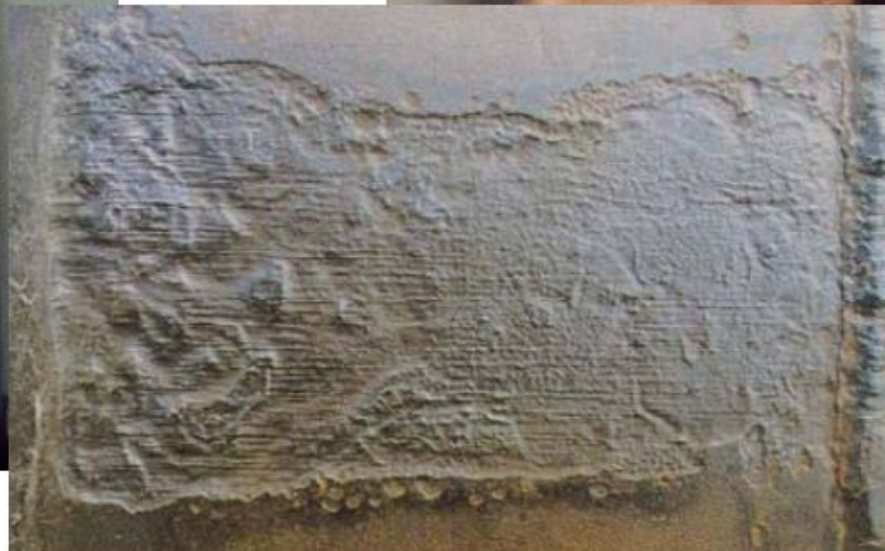
Morphology of MIC

- Blistering of liner due to corrosion.
 - Pits Initiate at holidays/defects in lining.
- Local area caps, fills with corrosion product
 - Differential aeration cell forms to accelerate corrosion
 - Can acidify over time further accelerating corrosion.
- Metal dissolution concentrated in small areas.
- Corrosion can become autocatalytic under cap.
 - Increasingly rapid rates of corrosion.
 - Unresponsive to changes in the bulk water chemistry.
