## 36"-48" RAFT Inspection Tool

- Water
- Industrial

## Overview

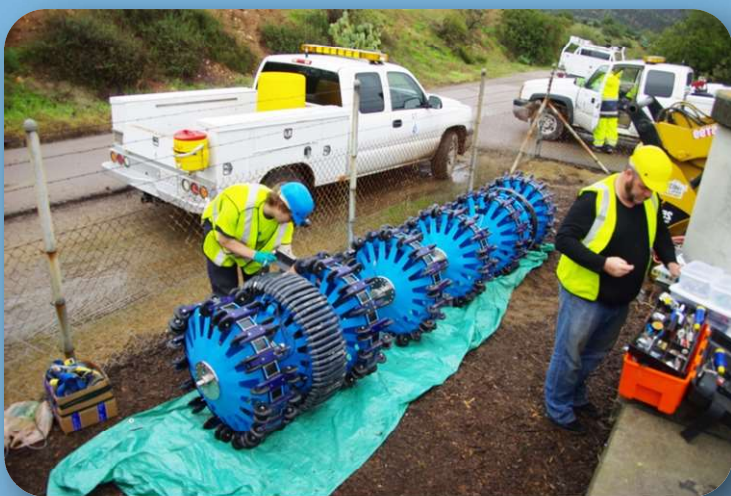
Released in 2017, the "RAFT" (Restricted Access Flexible Tool) is the latest in PICA's line of state-of-the-art pipe inspection tools. It is specifically designed to non-destructively assess the steel cylinder embedded within concrete pipes.

The RAFT's unique collapsible design enables technicians to insert the nine sections of the tool through small access locations that are only 19 inches in diameter, eliminating the need to excavate and cut the pipeline to gain access.

The tool is completely self-contained with battery power, data storage and distance tracking all integrated on the tool itself. Target pipe applications are Cement Mortar Lined and Coated (CML&C) Steel Pipes and Bar-Wrapped Steel Cylinder Concrete Pressure (AWWA C303) Pipes.

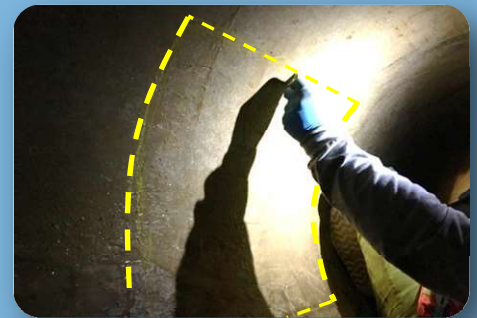
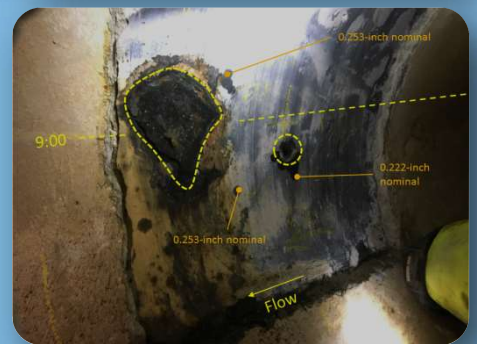
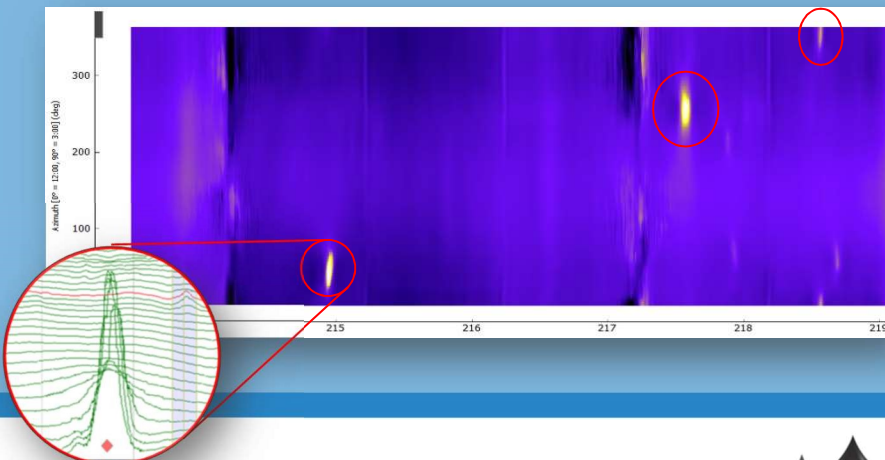
In early 2017, the RAFT tool completed a five-mile (8 km) inspection of 36-inch bar-wrapped concrete cylinder pipeline that carries millions of gallons of water per day to a water treatment plant for processing. Installed in the late 1940's, the feeder main is a critical part of the local water system and asset managers wanted to perform a detailed, non-destructive condition assessment.

The inspection identified several areas of thinning of the steel cylinder, which if left untreated would have resulted in serious pipeline failures in the near term. Even though the liner showed no signs of distress locally, the verification efforts revealed a compromised steel cylinder.
